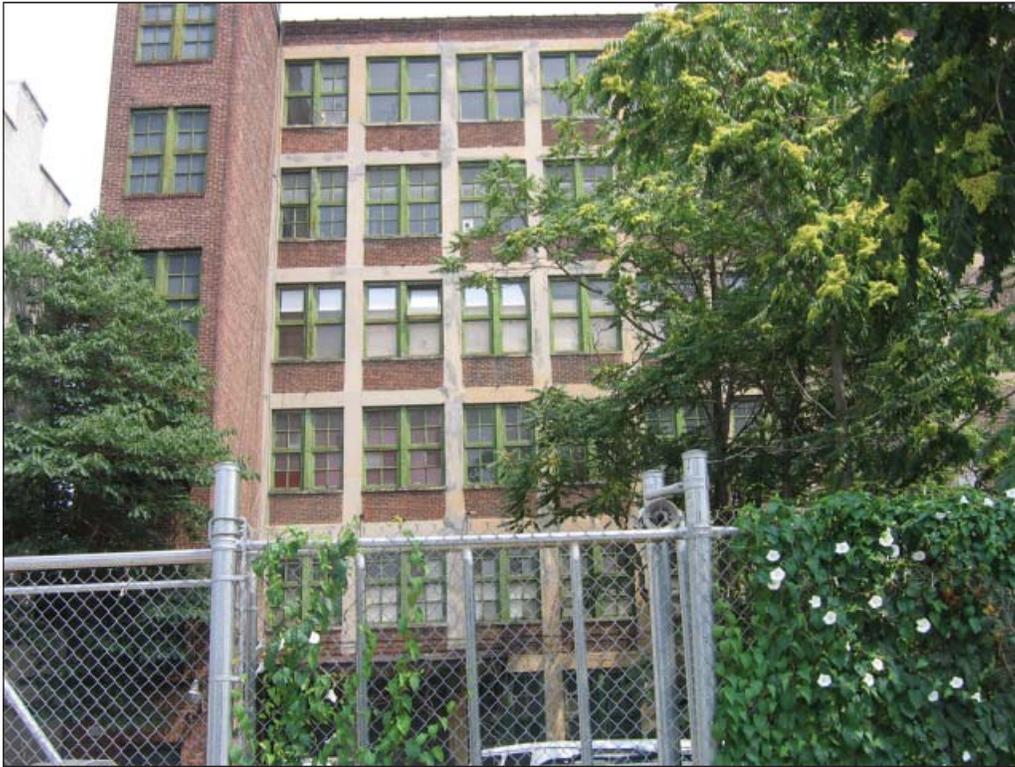
Photograph I 127-48-A

Lot 48 is located on the southeastern portion of the block bounded by Flatbush Avenue, Pacific Street, 6th Avenue, and Dean Street. As shown in the map above, the lot is irregularly shaped, with narrow frontages on both Dean Street and 6th Avenue. The lot hosts a six-story building set back from Dean Street (see Photograph A) and a small single-story building fronting on 6th Avenue (see Photograph B). The address for the six-story building is 475 Dean Street. The address for the single-story building is 38 6th Avenue. Together the buildings contain 40,640 gsf of space.

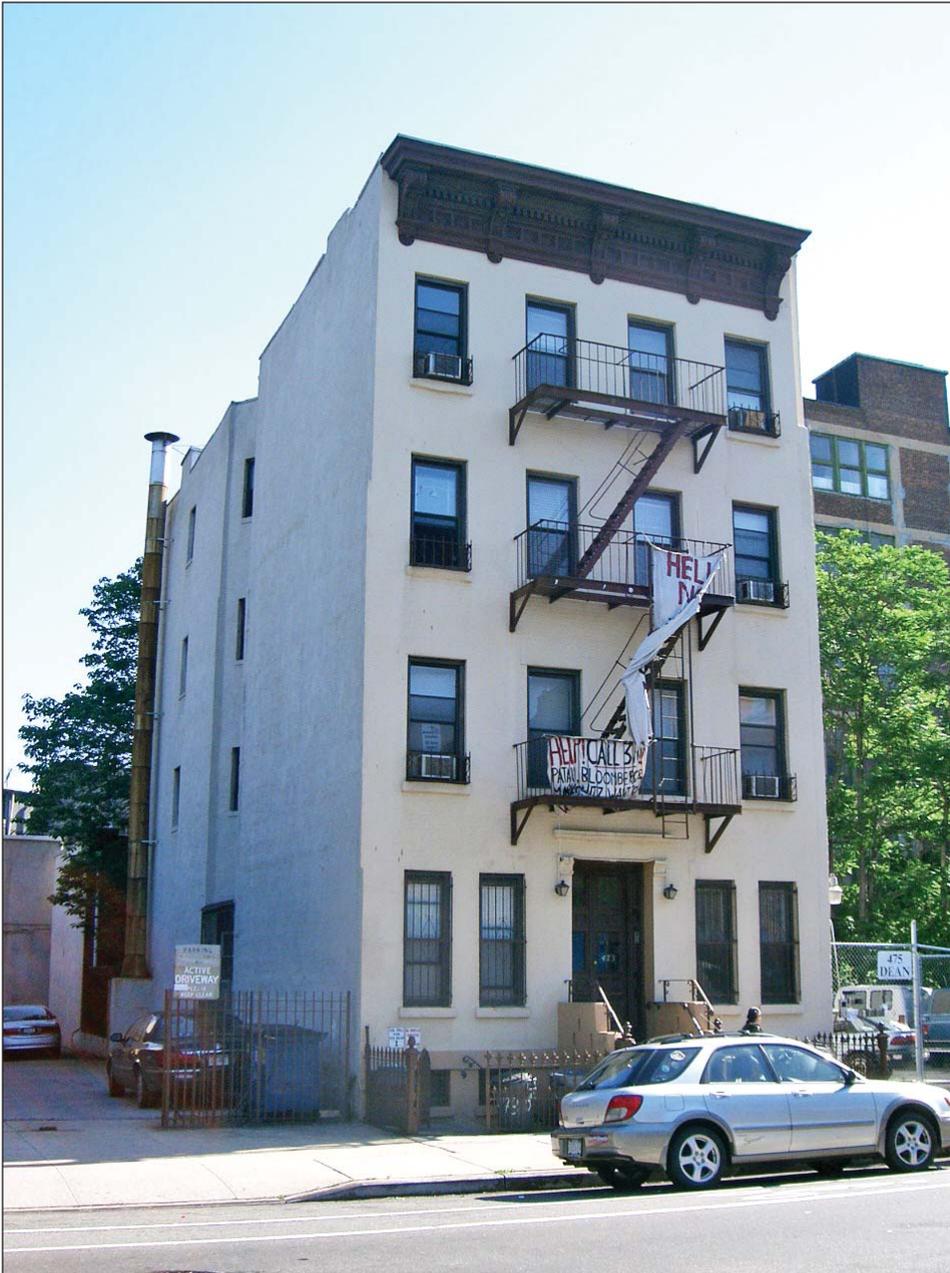
Photograph I 127-50-A

Lot 50 is located at 473 Dean Street, between Flatbush and 6th Avenues. The lot hosts a 7,800 gsf, four-story residential building (see Photograph A). Lot 50 is located in an R6B zoning district. With an FAR of 2.0, R6B districts are generally characterized by shorter, four-story rowhouses or apartment buildings. Lot 50 is owned by AYDC, which purchased the property in March 2006.

No unsanitary or unsafe conditions were identified as part of the visual assessment.

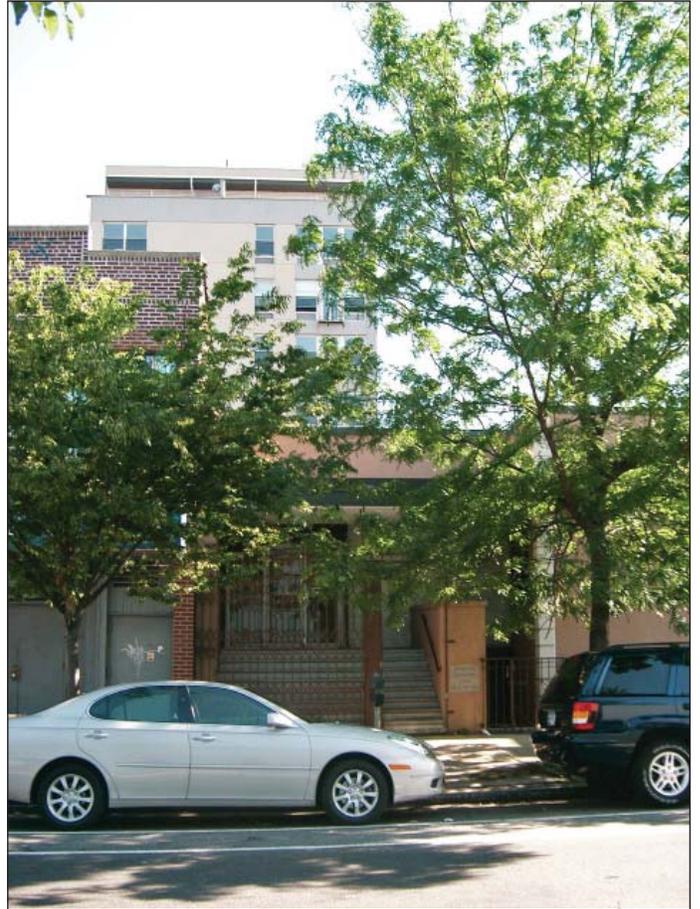
Photograph 1127-51-A

Lot 51 is located at 467 Dean Street between Flatbush and 6th Avenues. The lot hosts a 10,000 gsf, single-story building used as an office for the United Union of Roofers, Waterproofers and Allied Workers, Local Union No. 8 (see Photograph A). Lot 51 is located in an R6B zoning district. With an FAR of 2.0, R6B districts are generally characterized by shorter, four-story rowhouses or apartment buildings. According to the New York City Department of Finance, the building is currently owned by Waterproof Workers Realty.

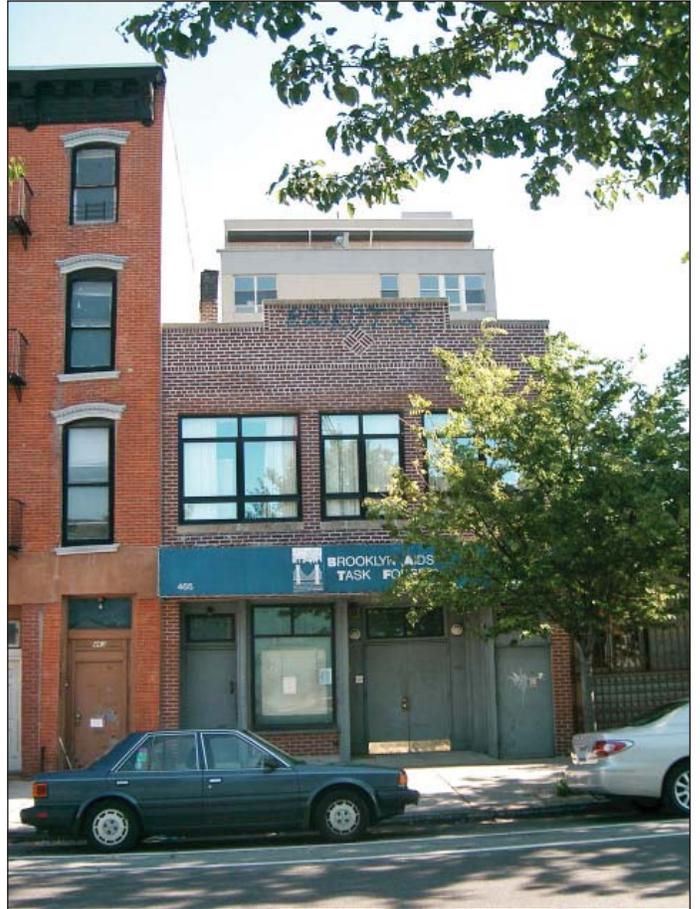
Photograph I 127-54-A

Lot 54 is located at 465 Dean Street between Flatbush and 6th Avenues. The lot is occupied by a vacant 4,908 gsf, two-story office building (see Photograph A).

With the exception of some graffiti above the second-floor windows and on the front doorway, the building exterior is in fair condition. The building's interior has suffered water damage in several areas. For example, as shown in Photographs B and C, leaking water has caused the paint to peel away from the walls above the second-floor windows and has damaged the underlying brickwork.

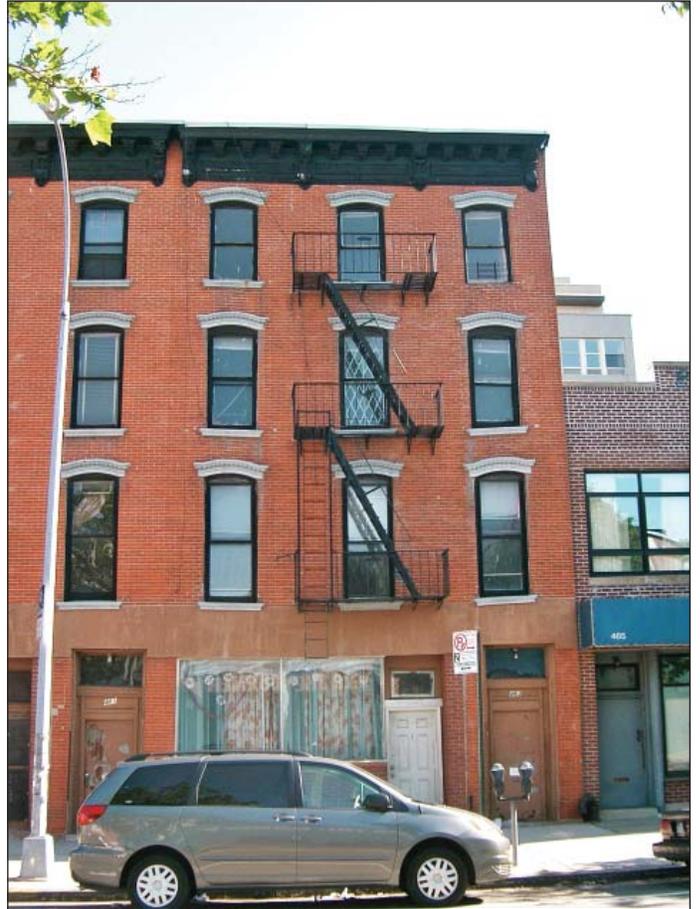
Photograph I 127-55-A

Lot 55 is located at 463 Dean Street between Flatbush and 6th Avenues. Until Spring 2006, the lot hosted a vacant 6,125 gsf, four-story residential building facing Dean Street (see Photograph A) and an abandoned and severely deteriorated three-story residential building in the rear of the lot (see Photograph B). The buildings were demolished in Spring 2006 by AYDC with approval from ESDC because of their dangerously deteriorated condition, as described below.

As indicated above, the buildings on lot 55 were demolished in Spring 2006. The exterior of the four-story building facing Dean Street appeared to be in fair physical condition. However, the interior was in a state of severe disrepair. The ceiling was damaged in several areas and parts of the ceiling had fallen, exposing the wooden beams and the subfloor above (see Photographs C and D). The floors of the building were littered with debris and all of the floors were sagging severely to the center-most point of the building (see Photograph E).

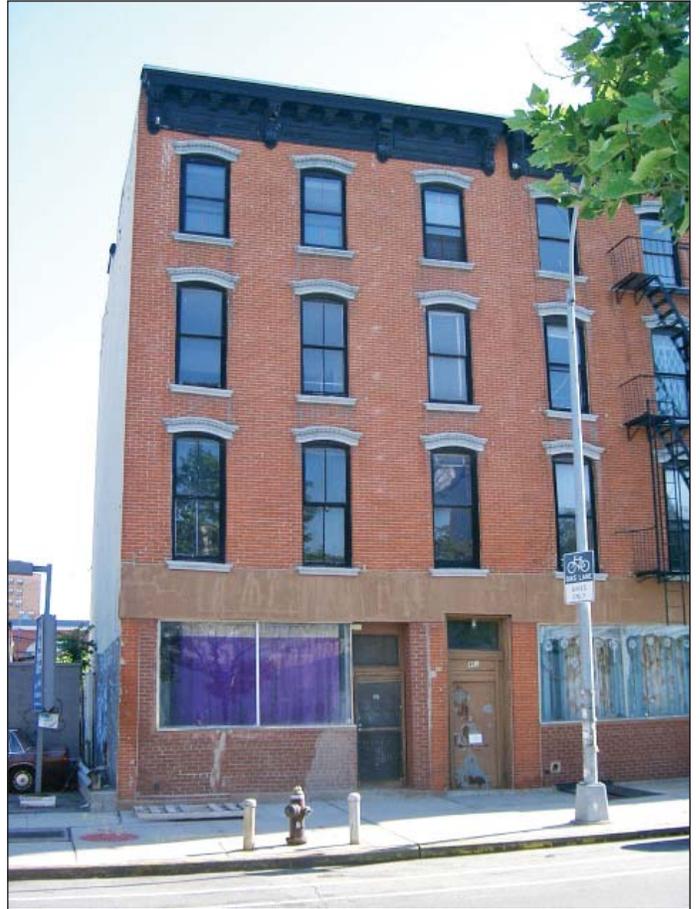
Photograph I 127-56-A

Lot 56 is located at 461 Dean Street between Flatbush and 6th Avenues. Until Spring 2006, the lot hosted a vacant 4,100 gsf, four-story residential building facing Dean Street (see Photograph A). The building was demolished by AYDC with approval from the ESDC because of its dangerously deteriorated condition, as described below.

As indicated above, the building on lot 56 was demolished in Spring 2006. The exterior of the building on lot 56 appeared to be in fair physical condition. However, there was graffiti painted on the building's western façade, and a portion of the stucco coating on that façade had crumbled, revealing the underlying brick, which also appeared to be crumbling (see Photograph B).

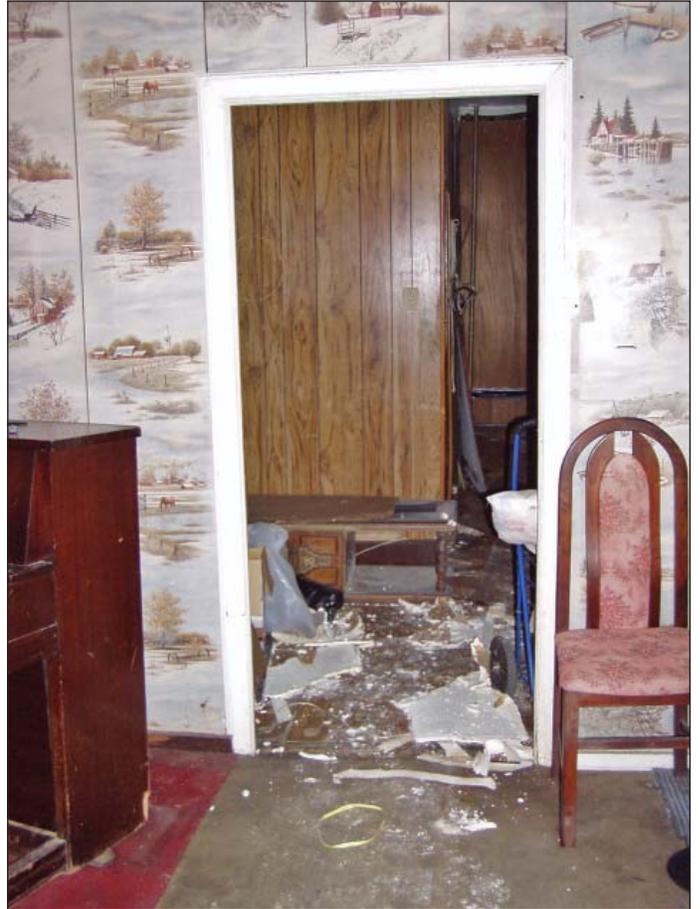
Photograph I 127-56-E

The interior of the building on lot 56 was in a severe state of disrepair. The ceiling is damaged in several areas and parts of the ceiling had fallen, exposing the wooden beams and lath and the subfloor above (see Photographs C and D). The floors in the building were sagging severely to the center-most point of the building and many floors were littered with debris from the falling ceilings and crumbling walls (see Photograph E). Water damage was evident throughout the building and mold was discovered on the back wall of one of the building's closets (see Photograph F).

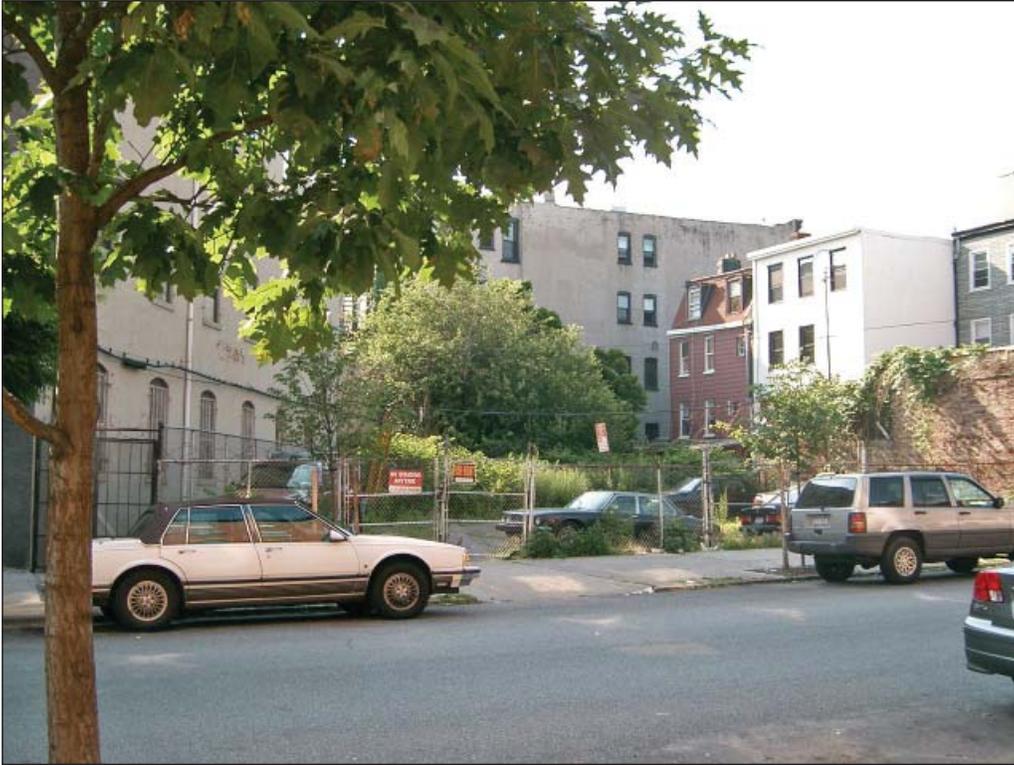
Photograph 1128-1,2-A

Lots 1 and 2 are located on 6th Avenue between Pacific and Dean Streets. Both properties are small, vacant, irregularly shaped lots. They are partially paved, and appear to be used for parking and to store broken down automobiles (see Photograph A).
