Block 1986 Lot 65

SITE CONDITION:	FAIR
------------------------	-------------

Manhattanville Neighborhood Conditions Study

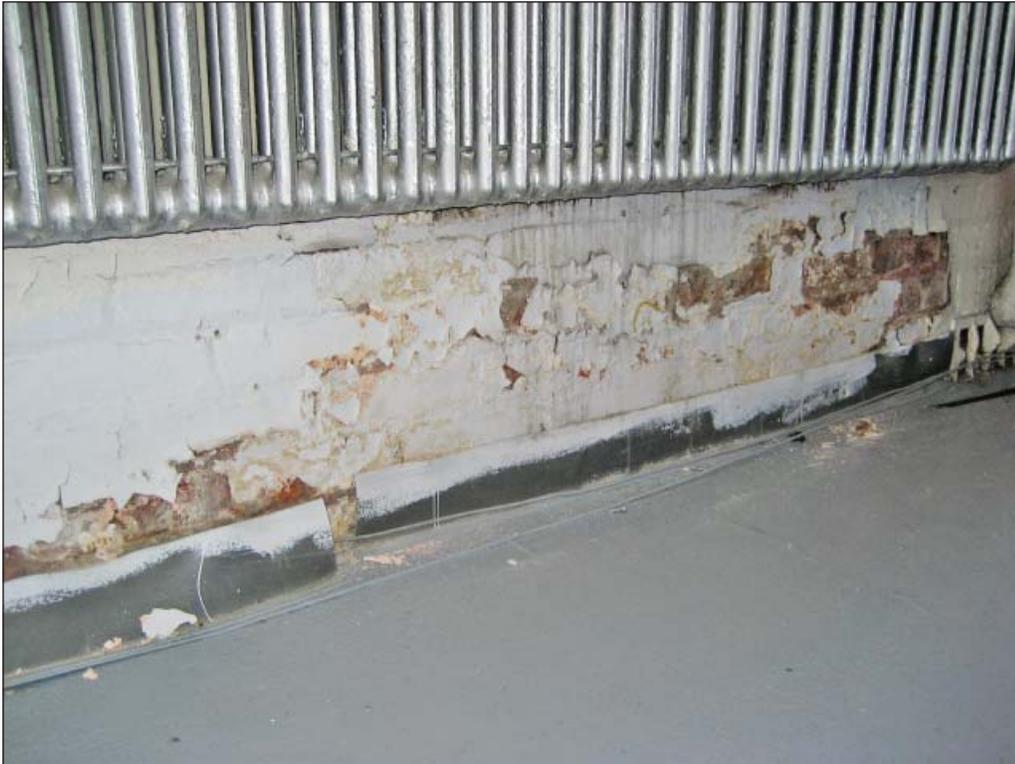
Photograph 1986-65-E

Water infiltration has caused local deterioration of several structural and non-structural elements, including water damage on the underside of the floor slab (see Photograph C); corrosion on the underside of a metal deck (see Photograph D); and cracks, efflorescence, and peeling paint on the walls (see Photographs E and F). Potential causes of water infiltration include holes, cracks, and air pockets on the roofing membrane (see Photograph G); damaged flashing and drains on the roof; deteriorated window sills and headers; damaged waterproof coatings on the window frames (see Photograph H); and a wide crack on the chimney (see Photograph I). There is peeling paint on the walls and ceiling in the parking garage on the first floor, which was likely caused by humidity from standing water in the garage or from low-quality paint (see Photograph J).
