SUMMARY REPORT
OF THE EXISTING
STRUCTURAL
CONDITION SURVEYS

Forest City Ratner Companies
One Metrotech Center North
11th Floor
Brooklyn, NY 11201

LZA TECHNOLOGY
641 Avenue of the Americas
New York, NY 10011
917-661-7800

November 07, 2005

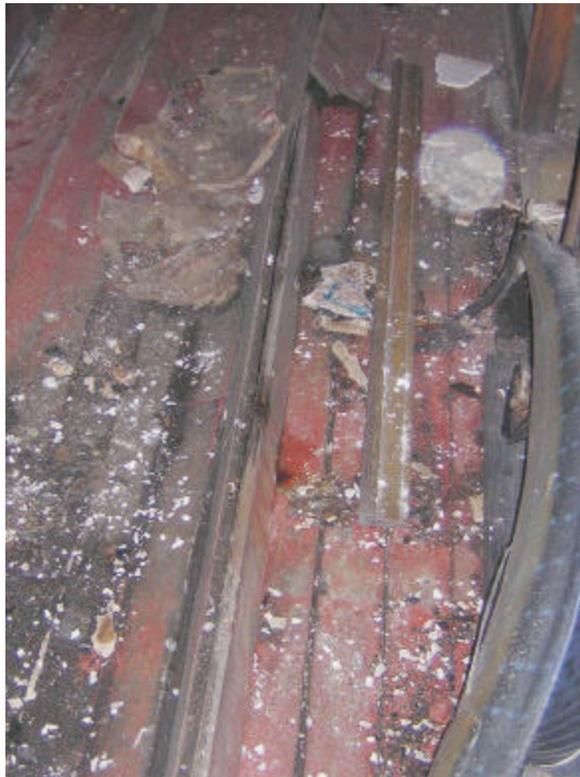
Photo No. 02 – 1st Floor Timber Flooring Water Damage of 620 Atlantic Avenue

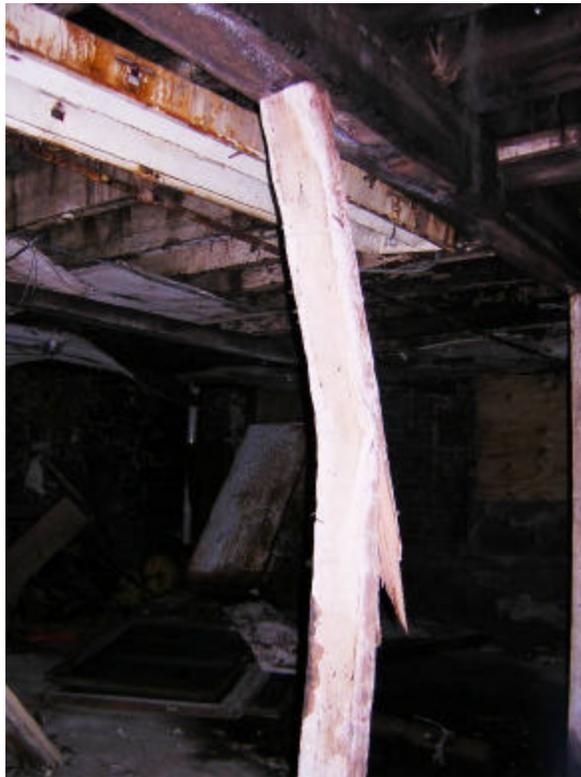
**Photo No. 13 – Timber Post Failure At
Basement of 461 Dean Street**

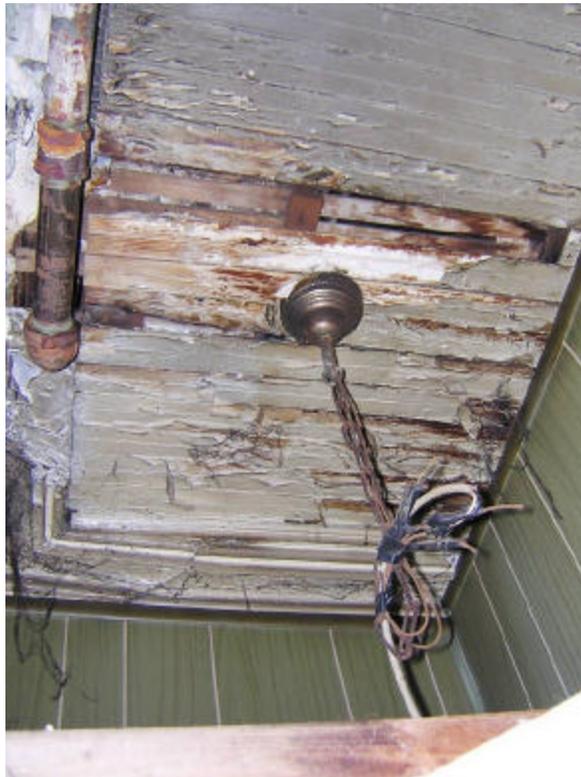
**Photo No. 23 – 2nd Floor Framing Water Damage At
1st Floor of 463 Dean Street**

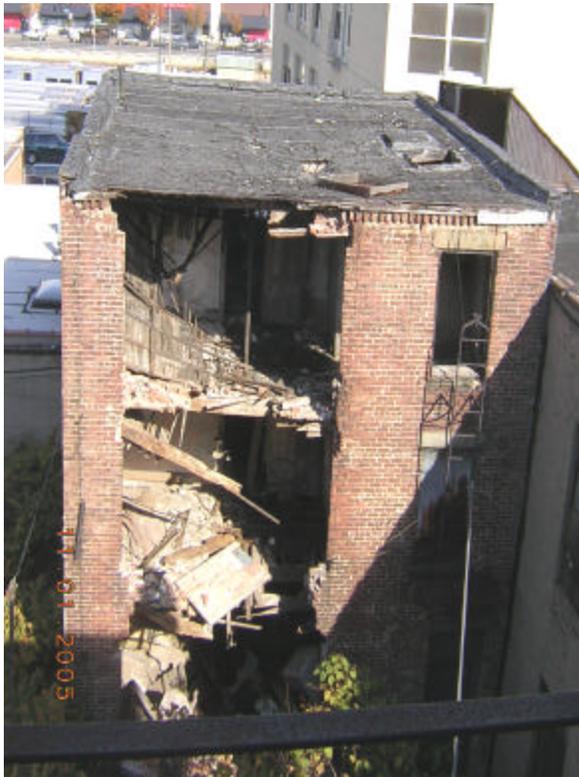
Photo No. 28 – Further Collapsed Portions of the Southern Non-Bearing Masonry Wall and Floor Framing of 463 Dean Street (Condition on November 01, 2005)

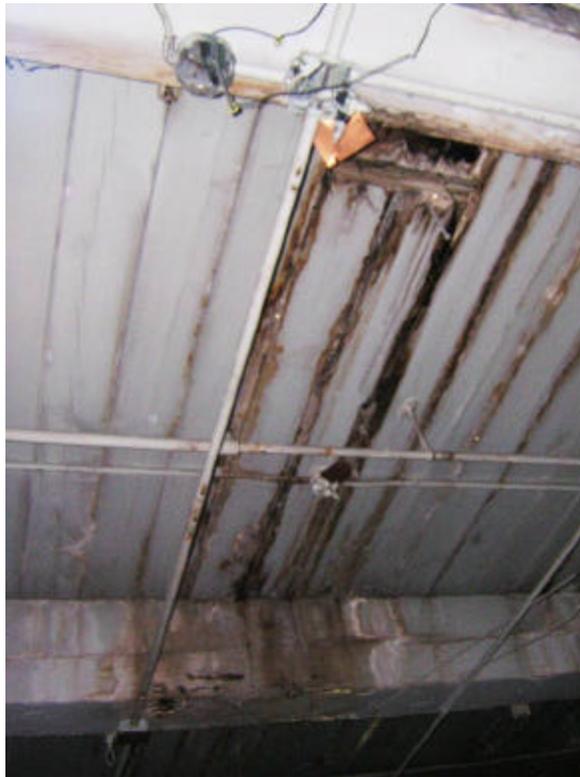
**Photo No. 29 – 3rd Floor Water Damaged Roof Framing
(Eastern Portion of Building) of 585-601 Dean Street**

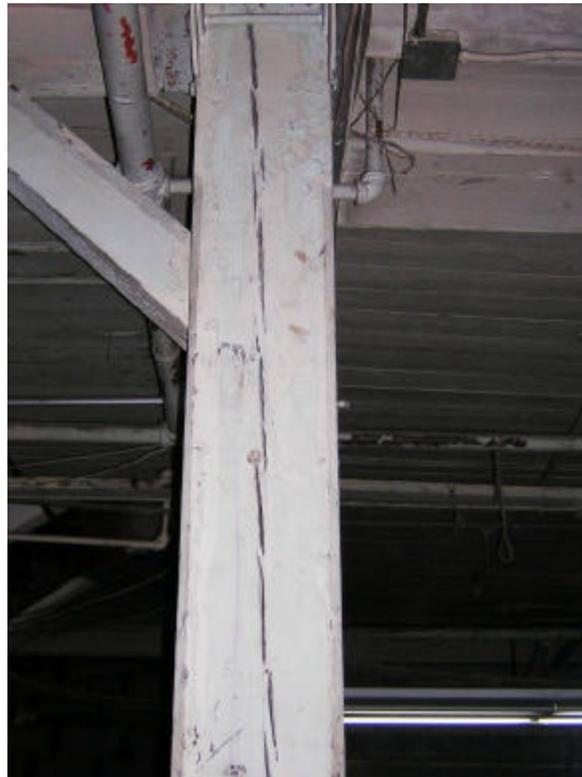
**Photo No. 38 – Vertical Crack Through 1st Floor Timber Column
(Western Portion of Building) of 585-601 Dean Street**

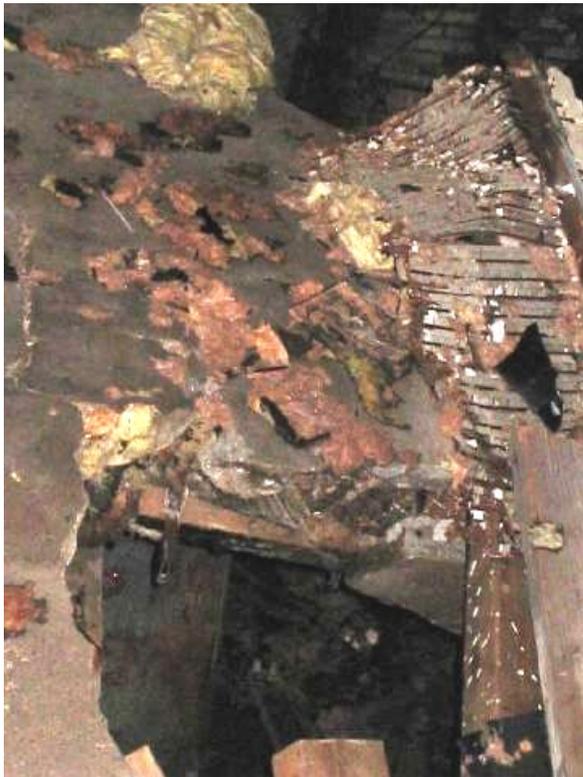
Photo No. 43 – Collapsed Slab At 1st Floor of 620 Pacific Street

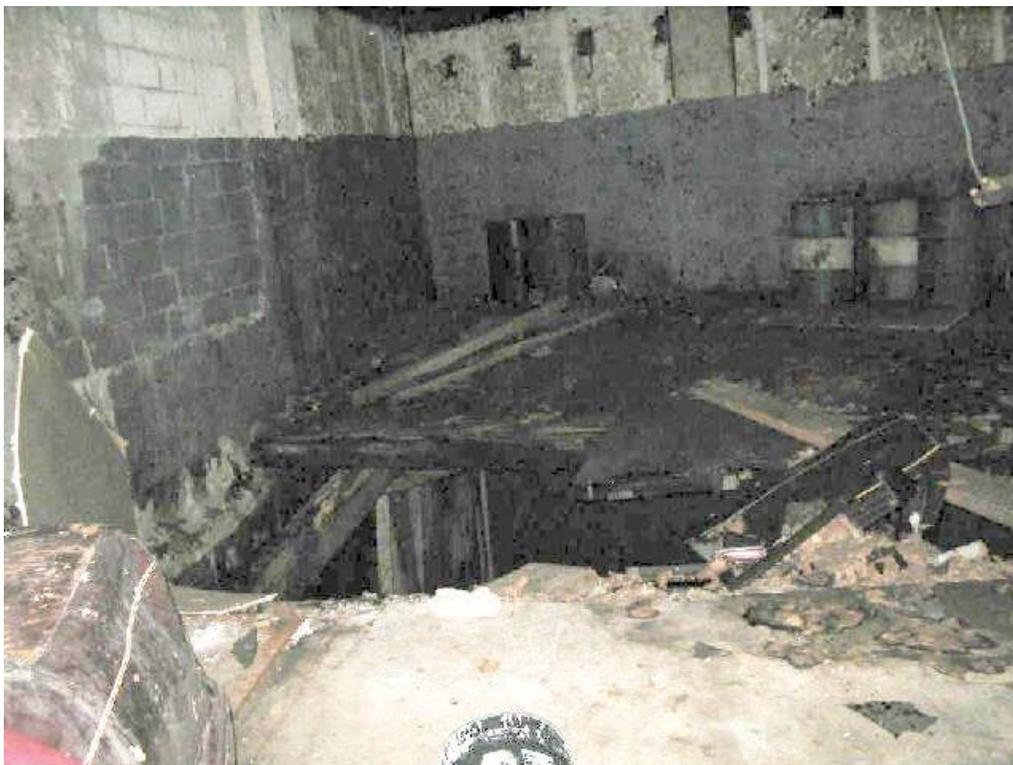
Photo No. 44 – Collapsed Slab At 1st Floor of 620 Pacific Street

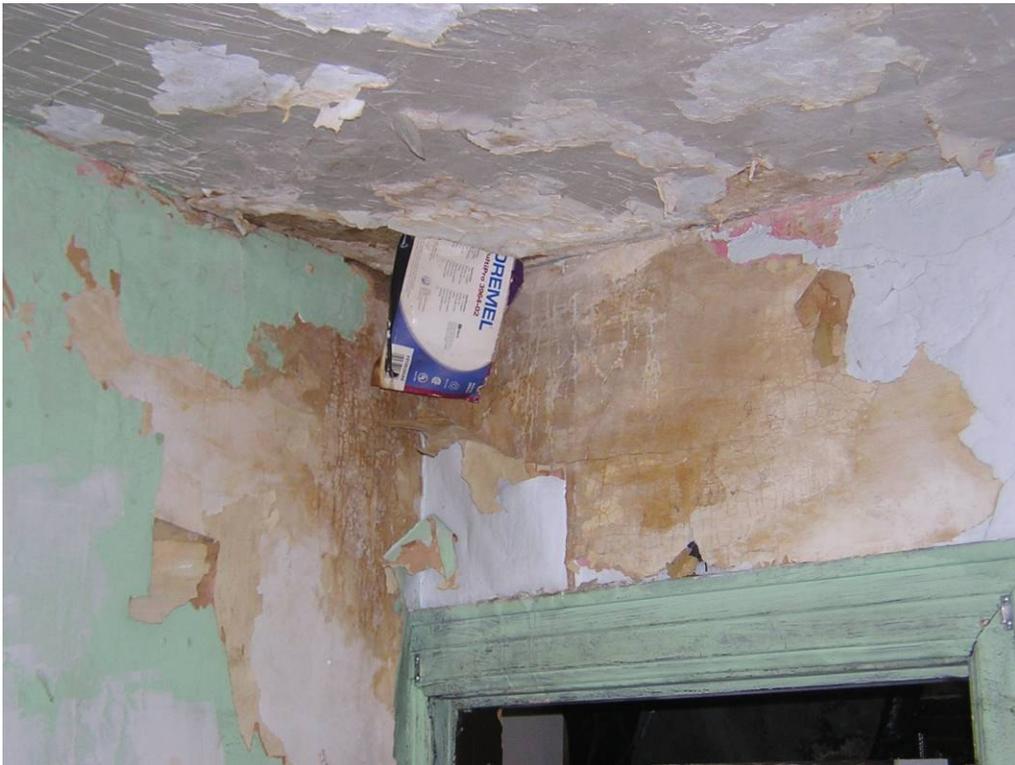
The roof's timber joists and floor boards in some locations appeared to be in poor condition with signs of water and/or moisture damage. The existing third floors plaster and pressboard ceilings show signs of water and/or moisture damage (Refer to Photo No. 23).

Photo No. 23 – Water Damage At 3rd Floor of Three-Story Building

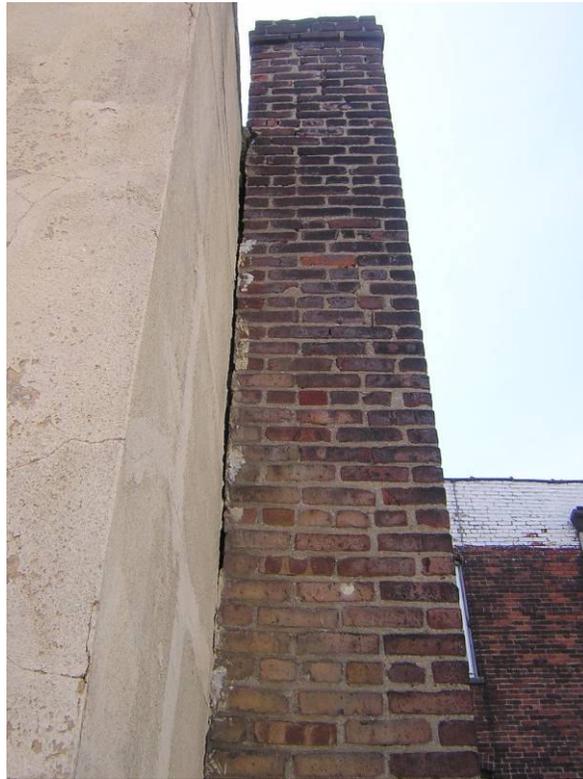
There is an exterior protruding masonry chimney above the roof on the northwest side of the building (Refer to Photo No. 4). The masonry chimney on the western face of the building is separating from the rest of the West masonry wall (Refer to Photo No. 25). This gap between the chimney and masonry wall is a sign of structural deterioration.

**Photo No. 25 – Gap Between Chimney and Masonry Wall
at Three-Story Building**

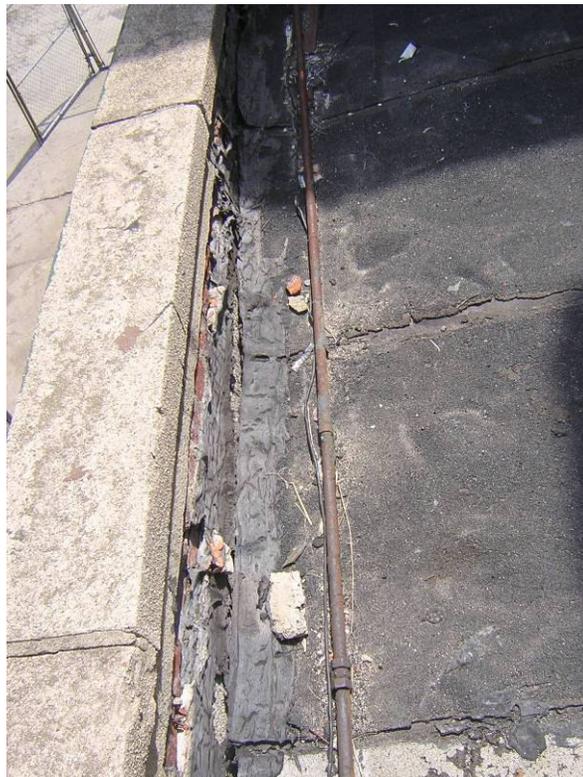
The black asphalt type mastic roofing membrane at the Auto Repair Shop appears to be in poor condition with numerous signs of deterioration present. The flashing along the North parapet of the building appears to be damaged and in some locations one can see directly into the building below (Refer to Photos No. 26 & 27). Water intrusion into the structure is evident at numerous locations.

Photo No. 26 – Damaged Roofing Membrane At Auto Repair Shop

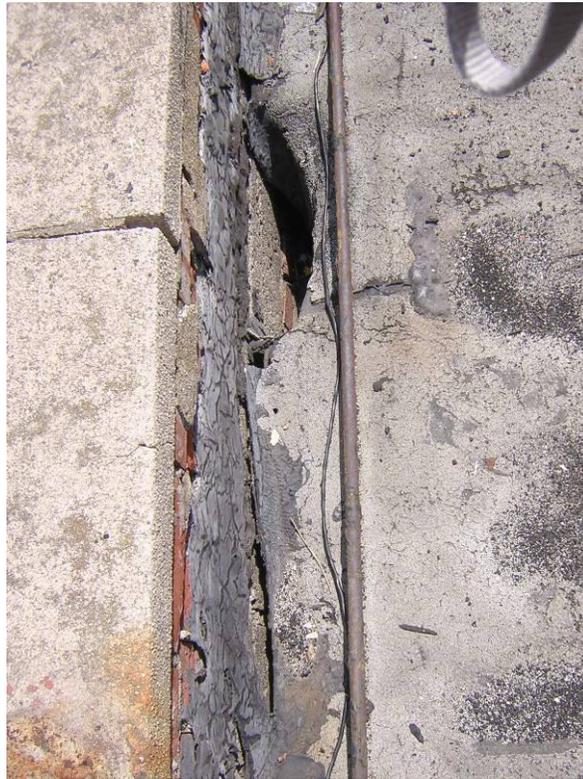
Photo No. 27 – Damaged Roofing Membrane At Auto Repair Shop

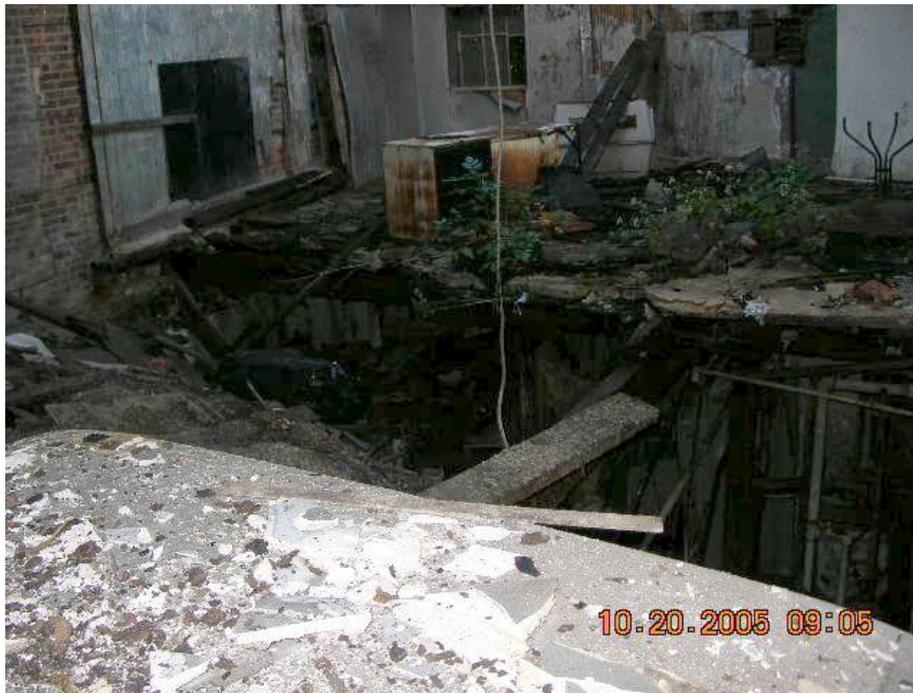
The overall condition of the building is that it is structurally unsafe. Portions of the roof and 1st floor have collapsed (Refer to Photos No. 2 & 3). These collapsed and damaged portions of the roof and floor indicate that major structural deterioration of the building has occurred and that the structure is unsafe.

Photo No. 3 – Collapsed Portion of 1st Floor

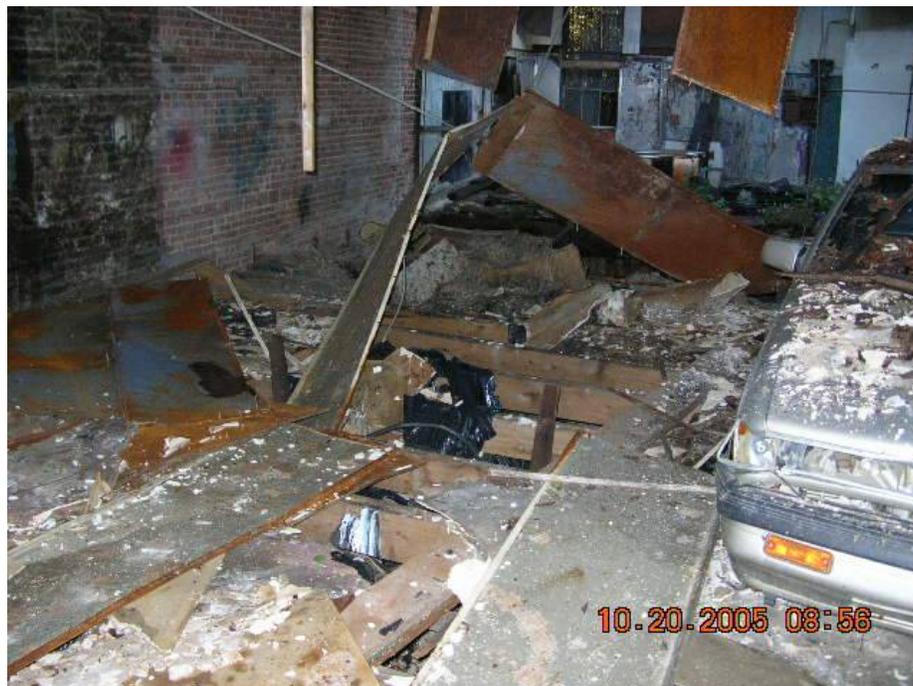
The interior of the structure as observed is in a serious state of disrepair from water damage and exposure to the elements (Refer to Photos No. 4 & 5). The timber floor framing is deteriorated and portions of it may continue to collapse due to the water damaged floor structure (Refer to Photo 6).

Photo No. 4 – General Condition of Building

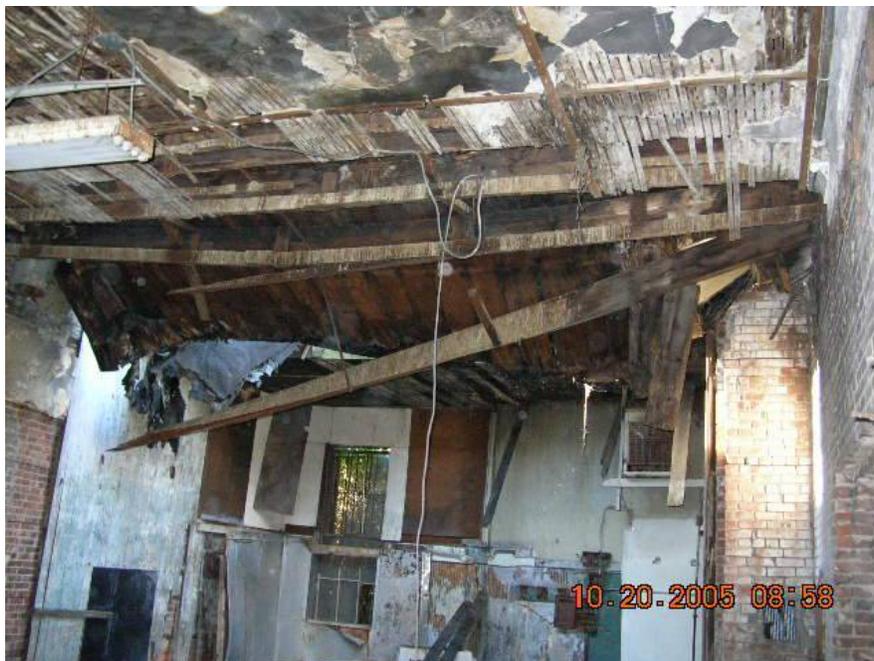
The roof membrane is deteriorated and in many locations no longer exists. There is a partial collapse at the southern end of the roof. There are numerous holes through the roof that are open to the elements (Refer to Photo 7). The framing shows signs of deterioration and portions of it may continue to collapse (Refer to Photo No. 8). Also, the windows are open and/or broken thus open to the elements.

Photo No. 8 – Deterioration of Timber Roof Framing
